TECHNICAL NOTE 2996

APPRAISAL OF HAZARDS TO HUMAN SURVIVAL IN AIRPLANE CRASH FIRES

By Gerard J. Pesman

Lewis Flight Propulsion Laboratory
Cleveland, Ohio

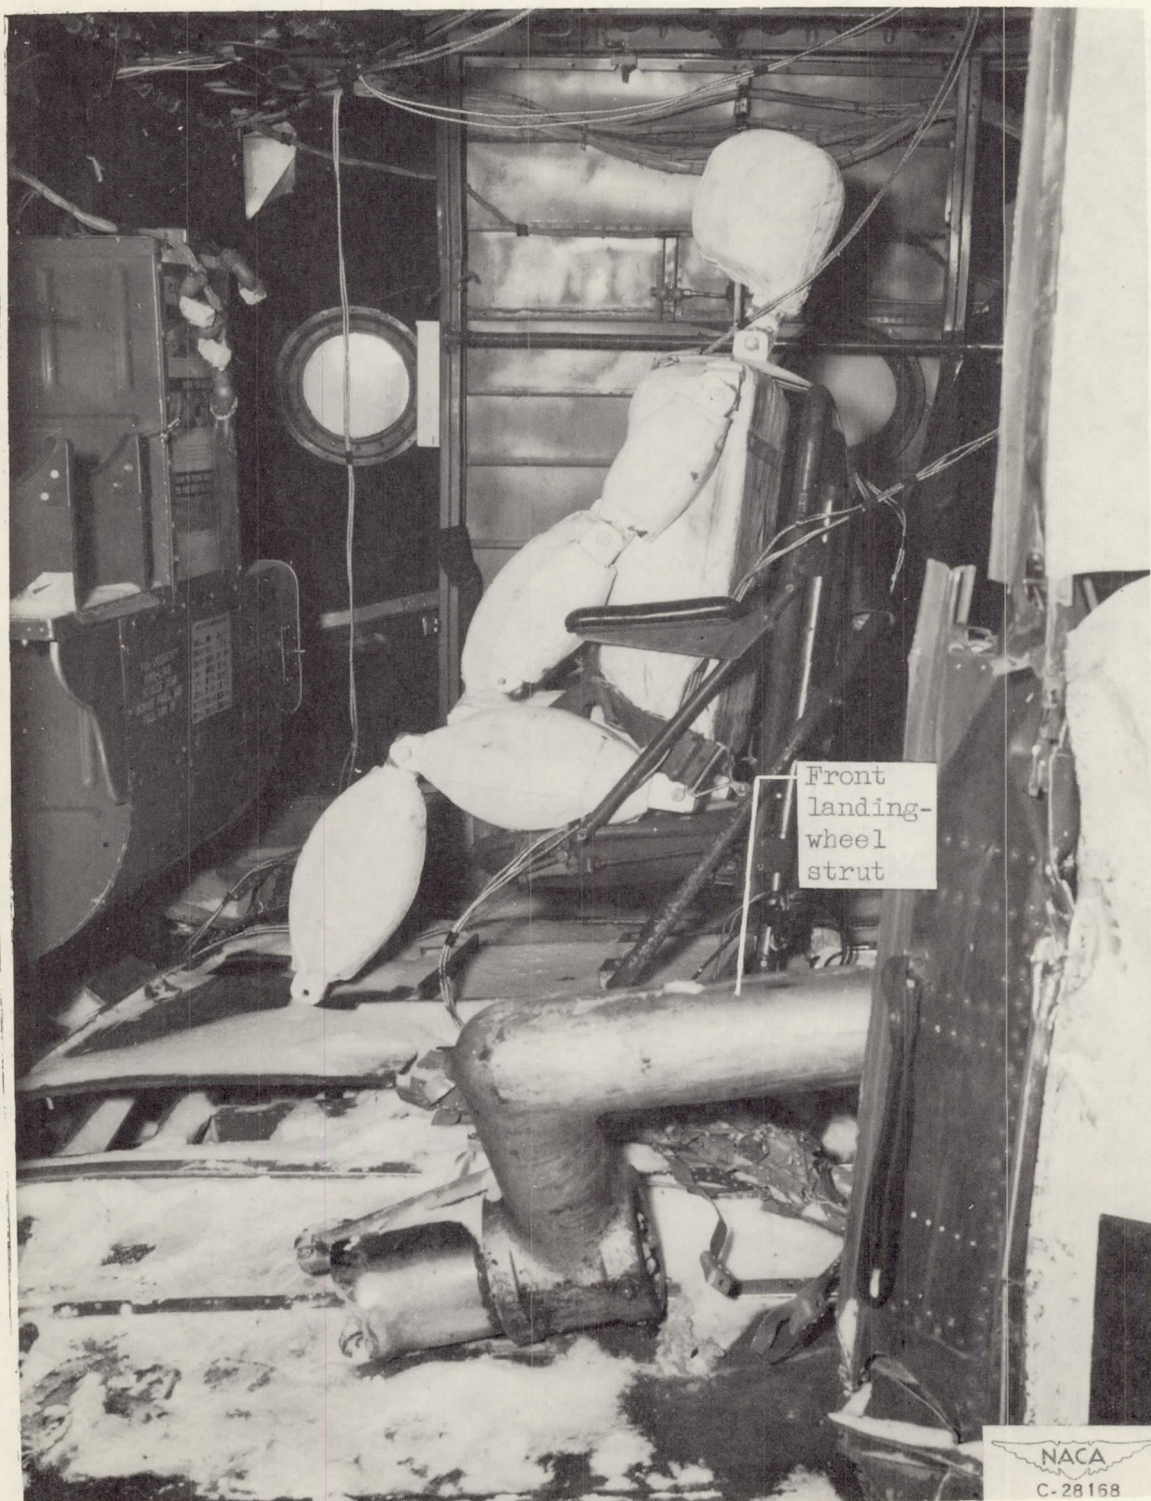
Figure 31. - Position of front landing-wheel strut after penetrating floor and rebounding from rear of cabin.

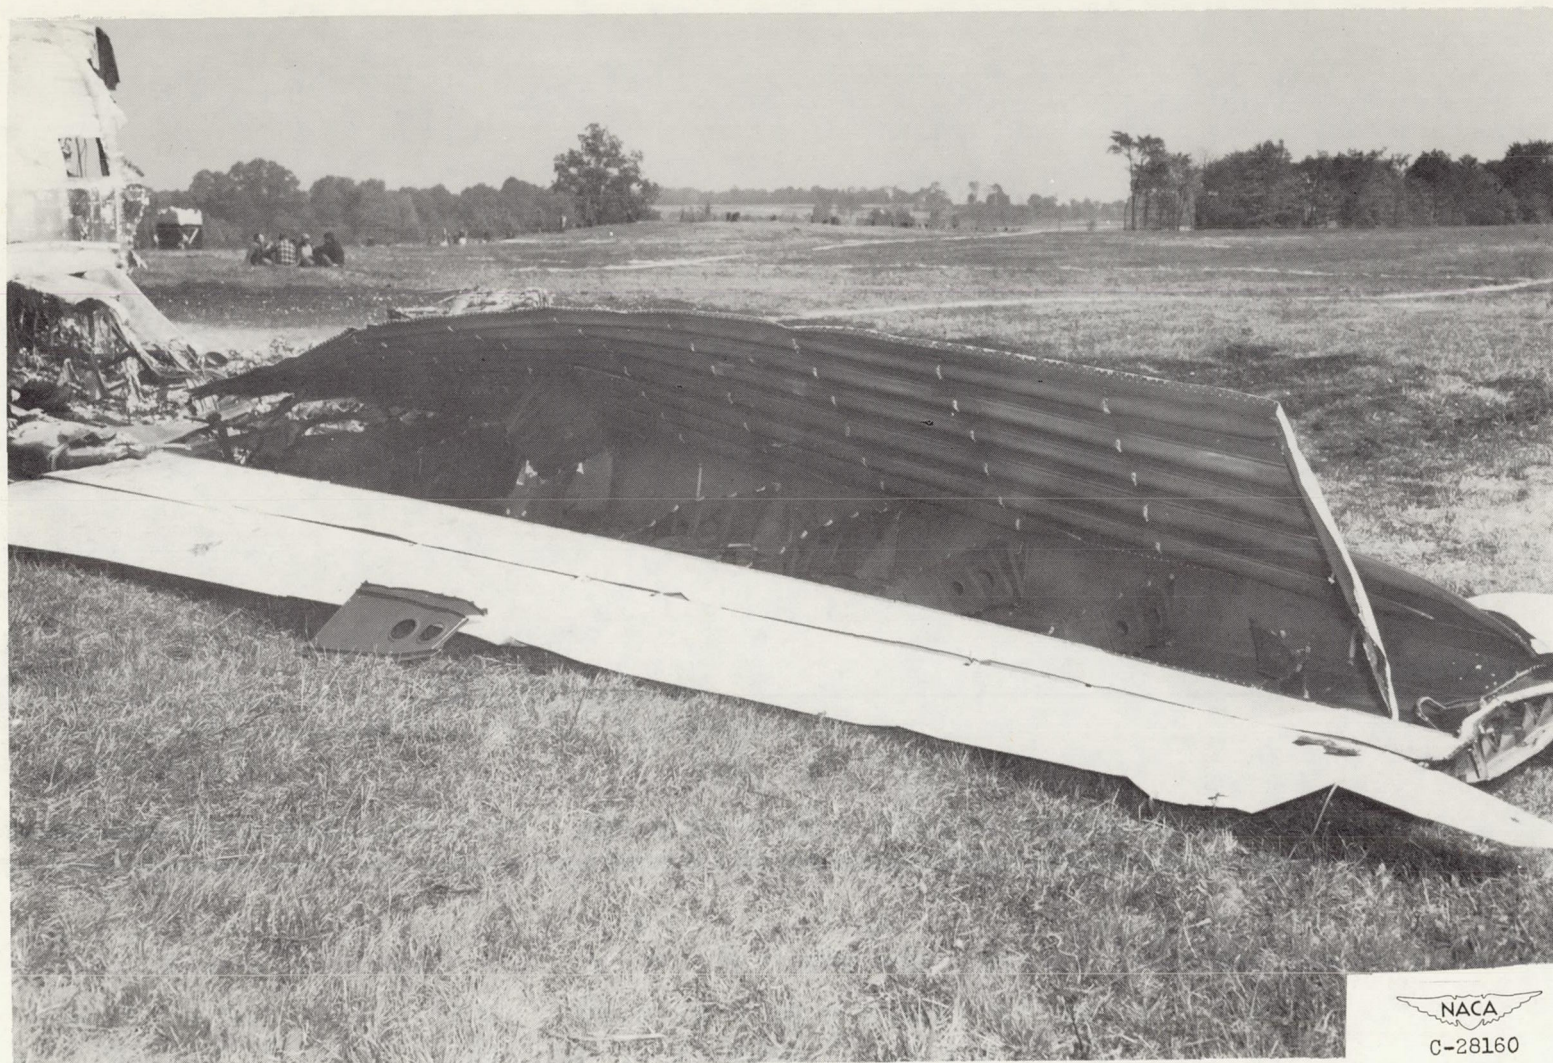
(c) Front view of damage to wing structure.

Figure 34. - Concluded. Wing explosion resulting from ignition of fuel-air mixture accumulated in wing while airplane was sliding to a stop.

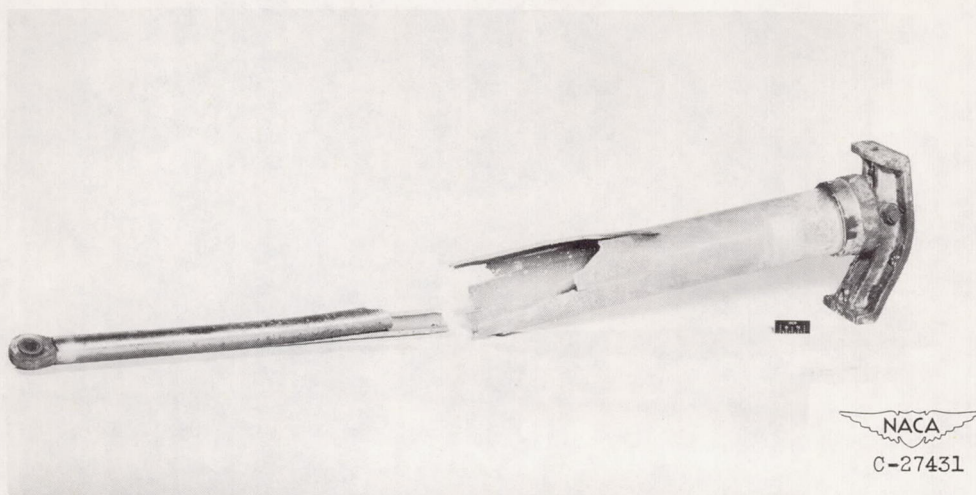
Figure 36. - Damage resulting when hydraulic shock strut was heated by aircraft fire and exploded.

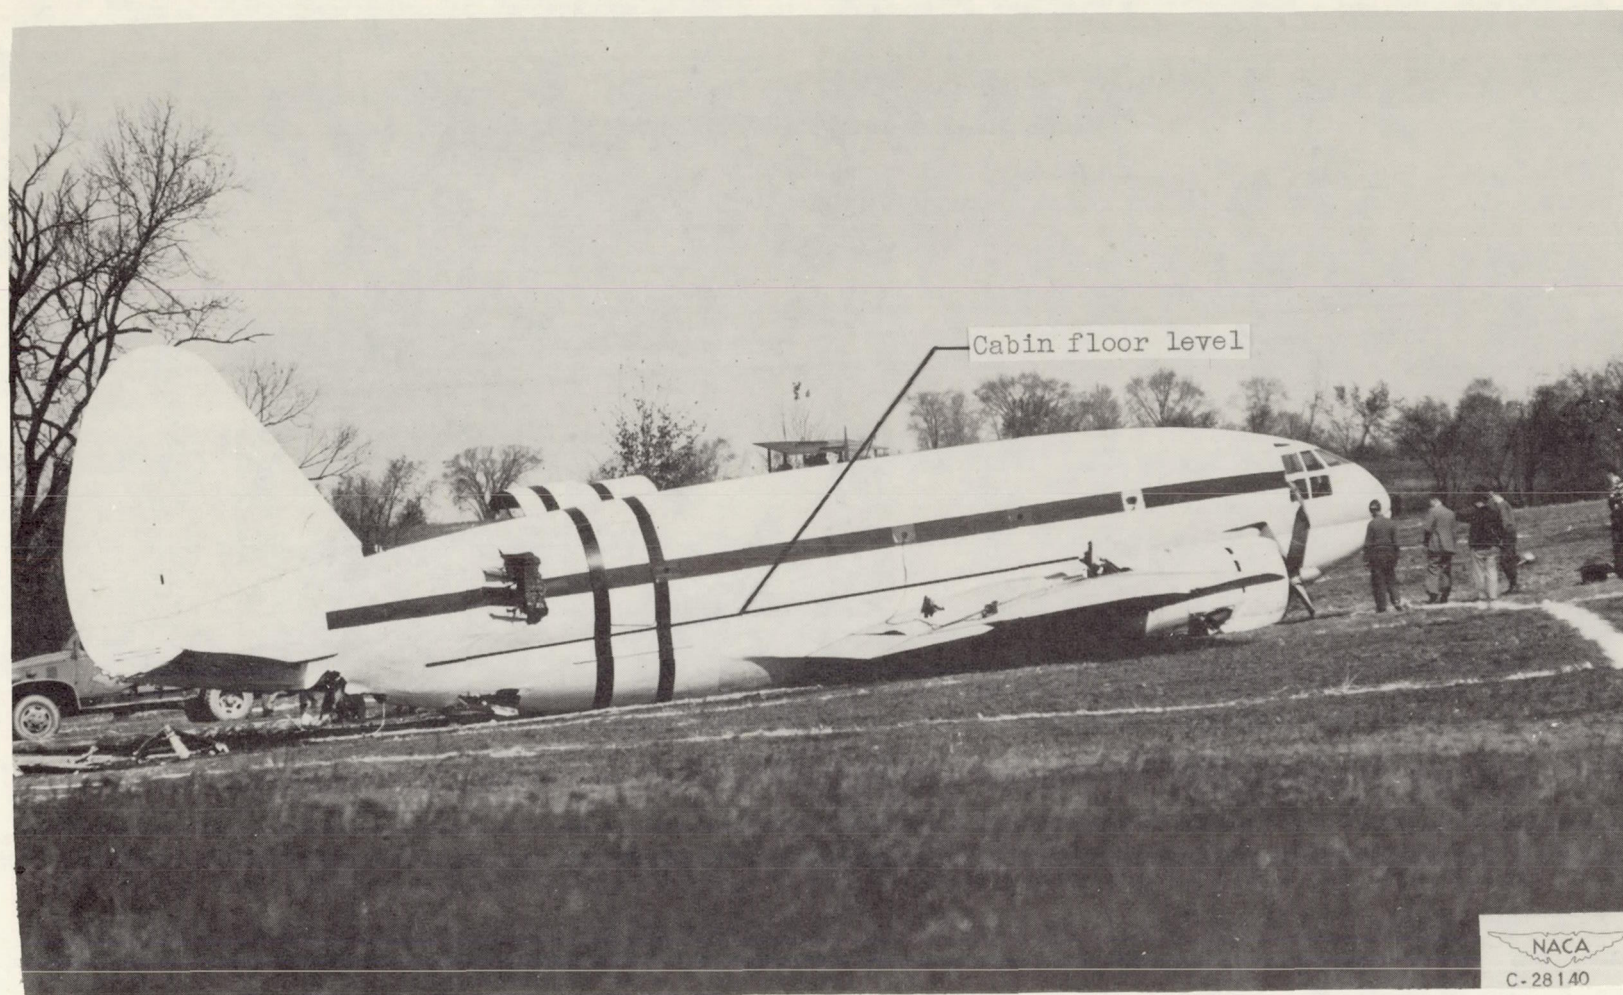
Figure 38. - Insignificant damage to floor structure of low-midwing, twin-engine type aircraft resulting from simulated take-off accident. Cabin floor lies along indented joint line between two curved sections of fuselage.

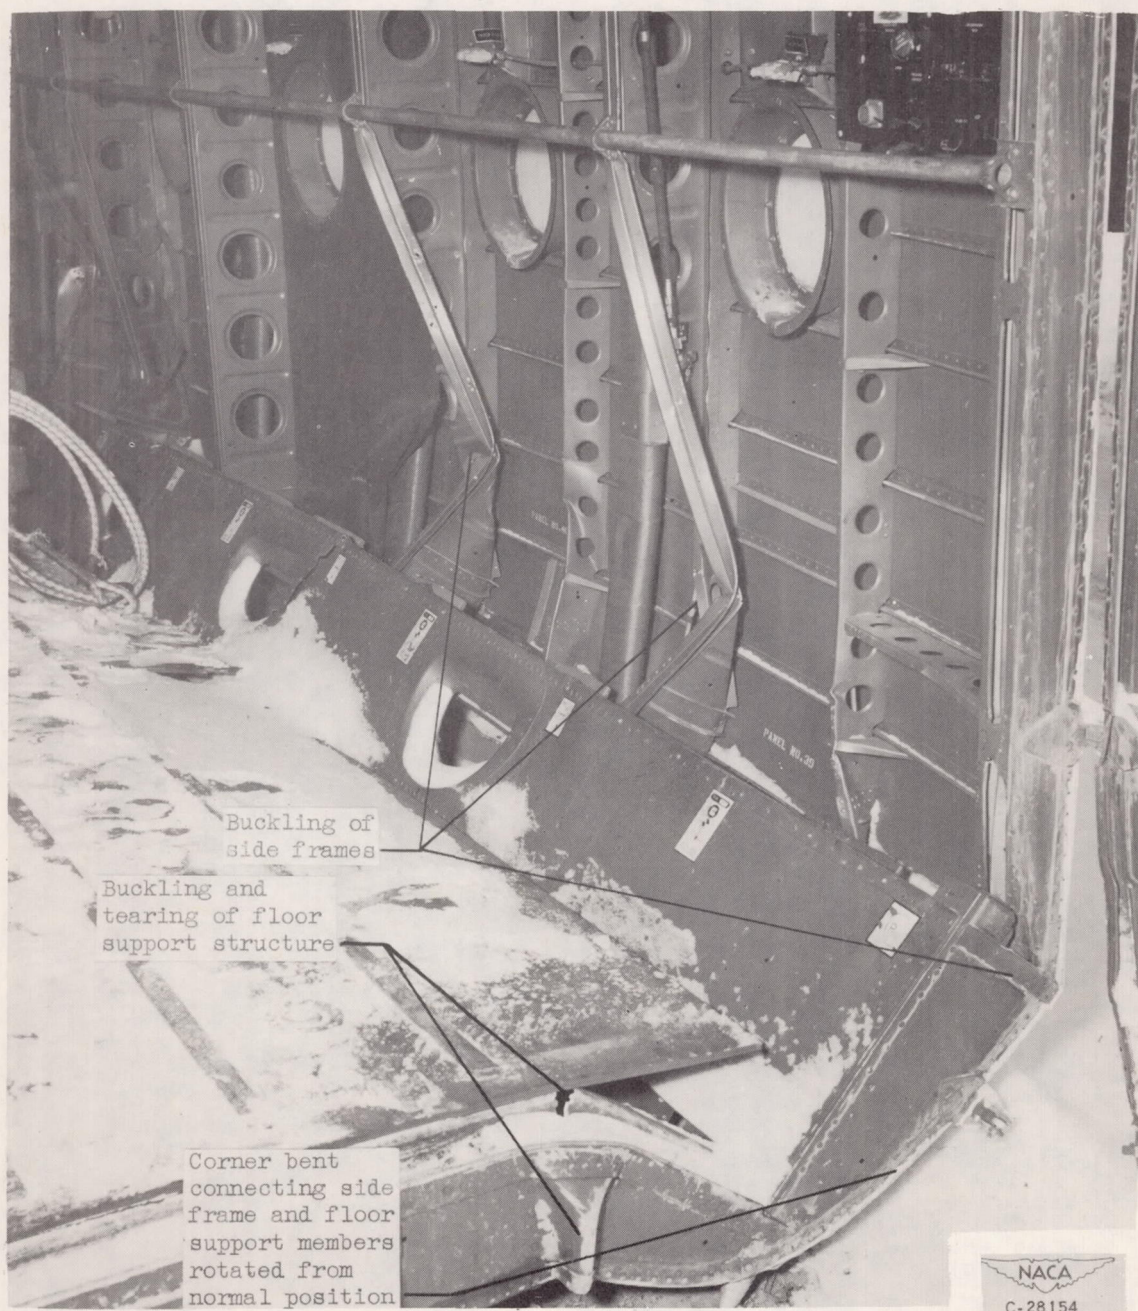
Figure 39. - Damage to packet-type cargo airplane floor structure and side framing resulting from vertical impact and sliding friction on hard ground surface.

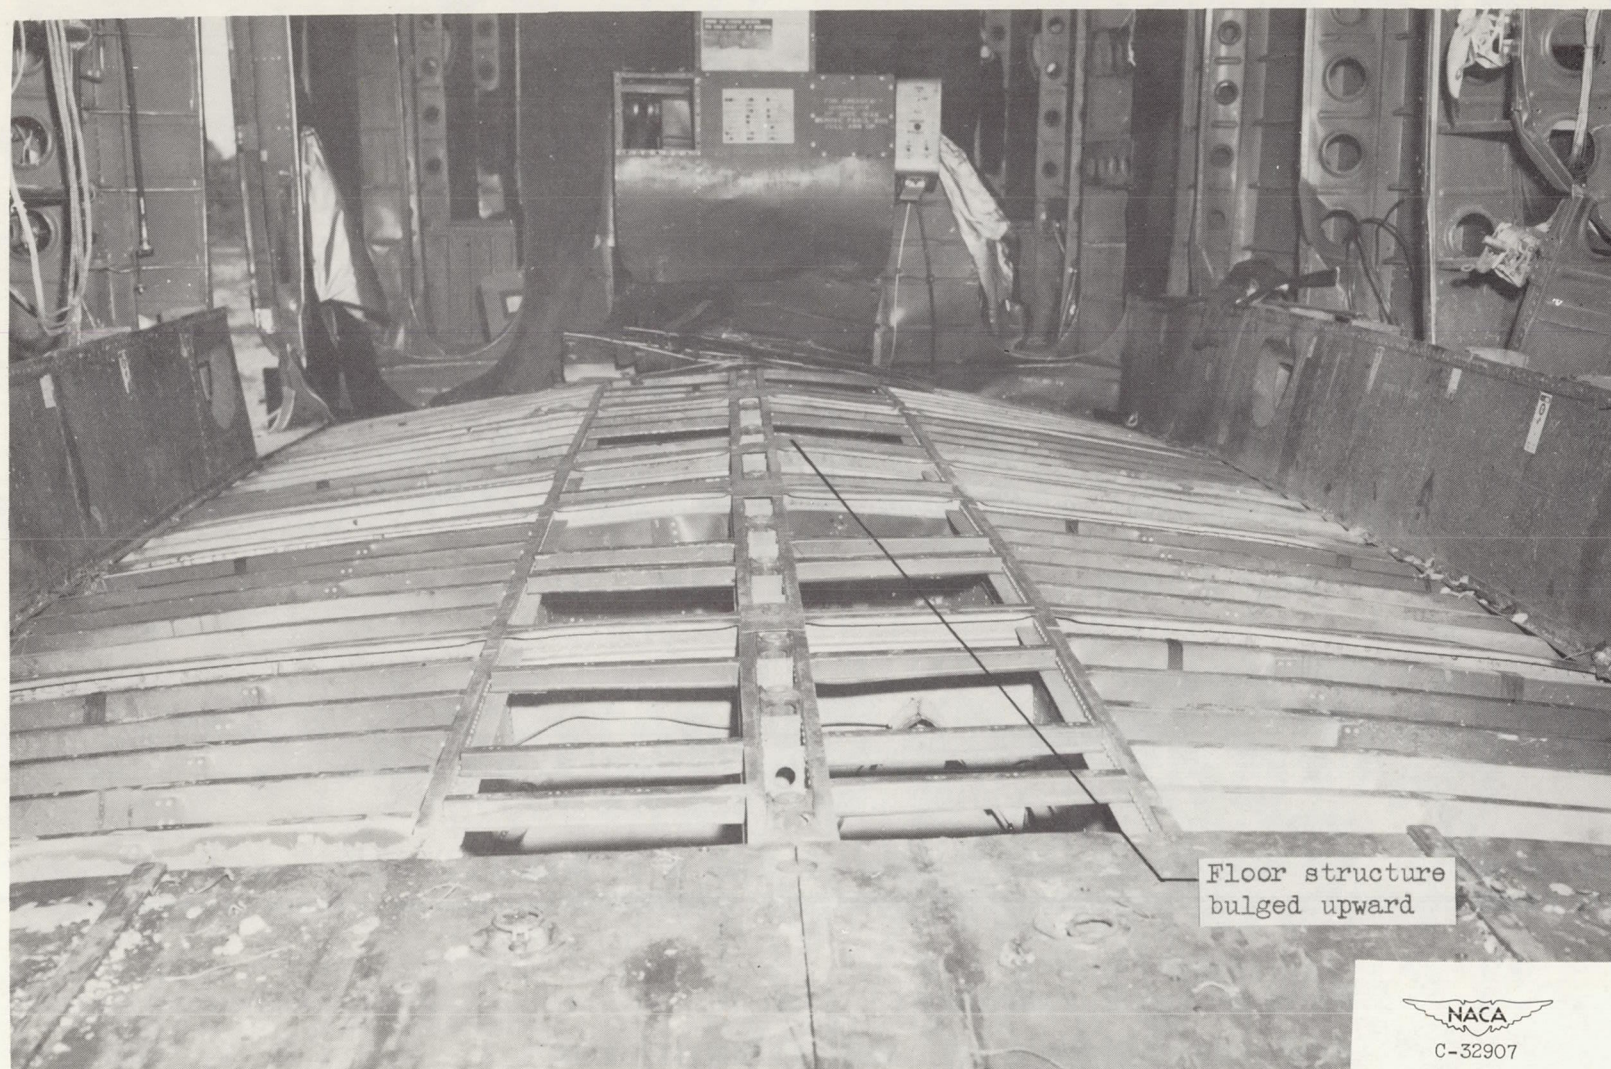
Figure 40. - Floor support structure of cargo-type airplane bulged slightly upward as a result of nose-wheel damage and landing impact upon hard dirt surface.

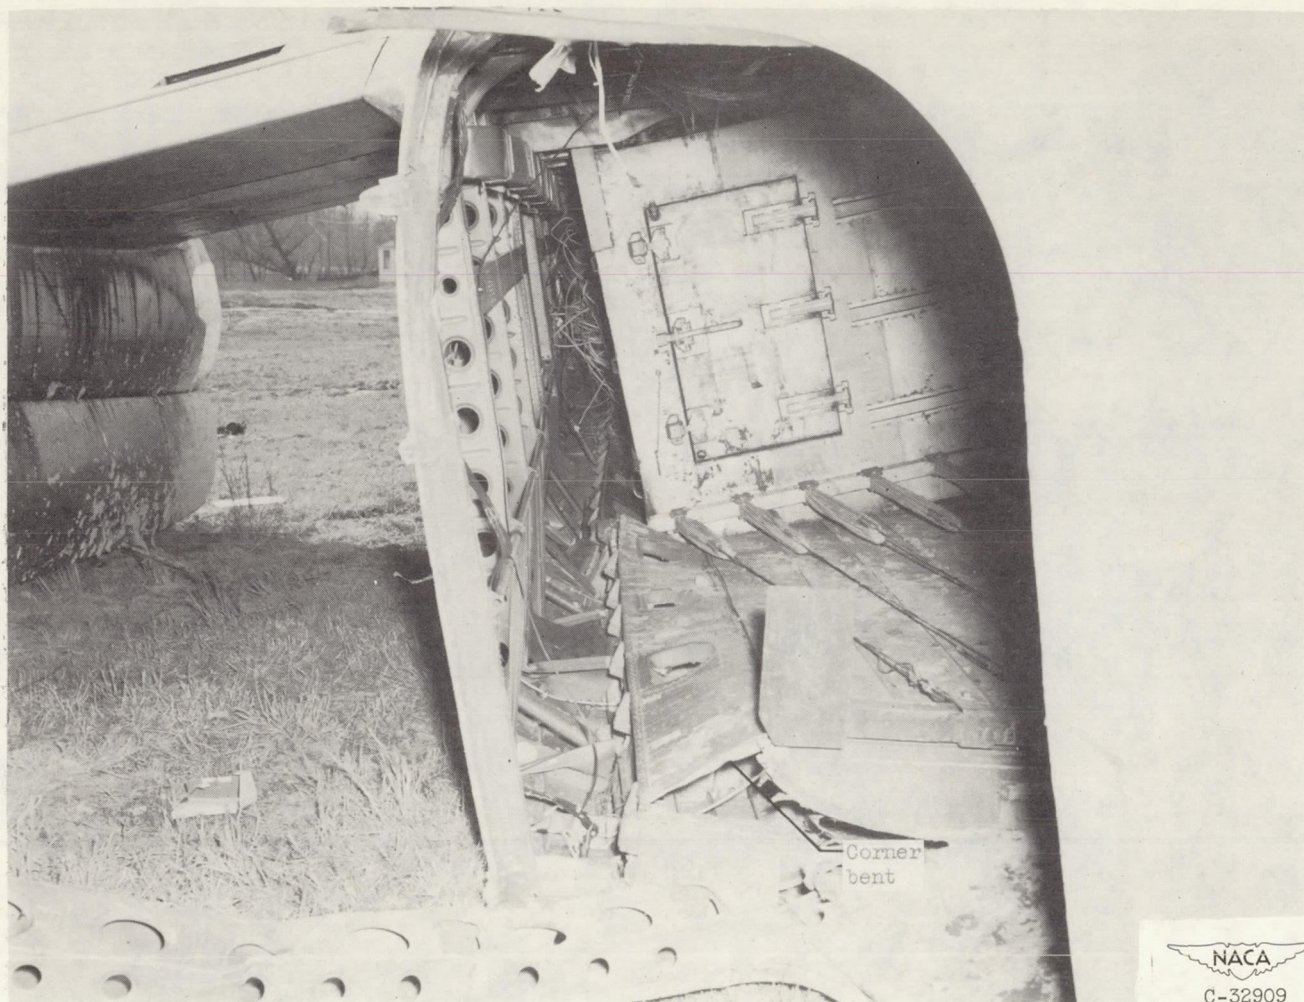
Figure 42. - Corner bent rotated from 90° to about 120° from its normal position by combined lateral and vertical forces caused by ground loop.

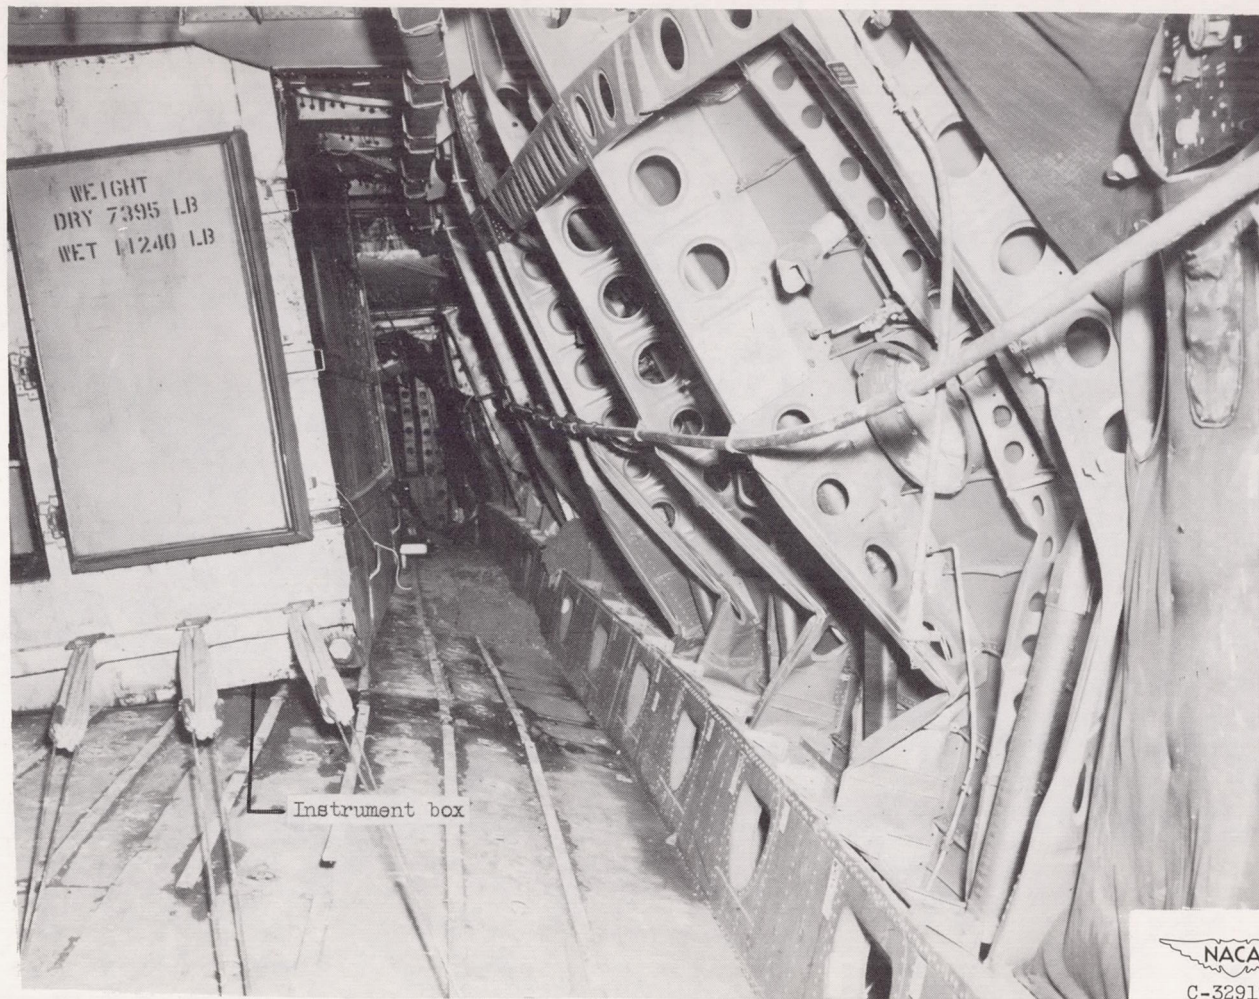
Figure 43. - Continued. Incipient lateral collapse of rectangular-type fuselage framing resulting from lateral load imposed by ground-loop crash.

(c) Buckling of side frame structure.

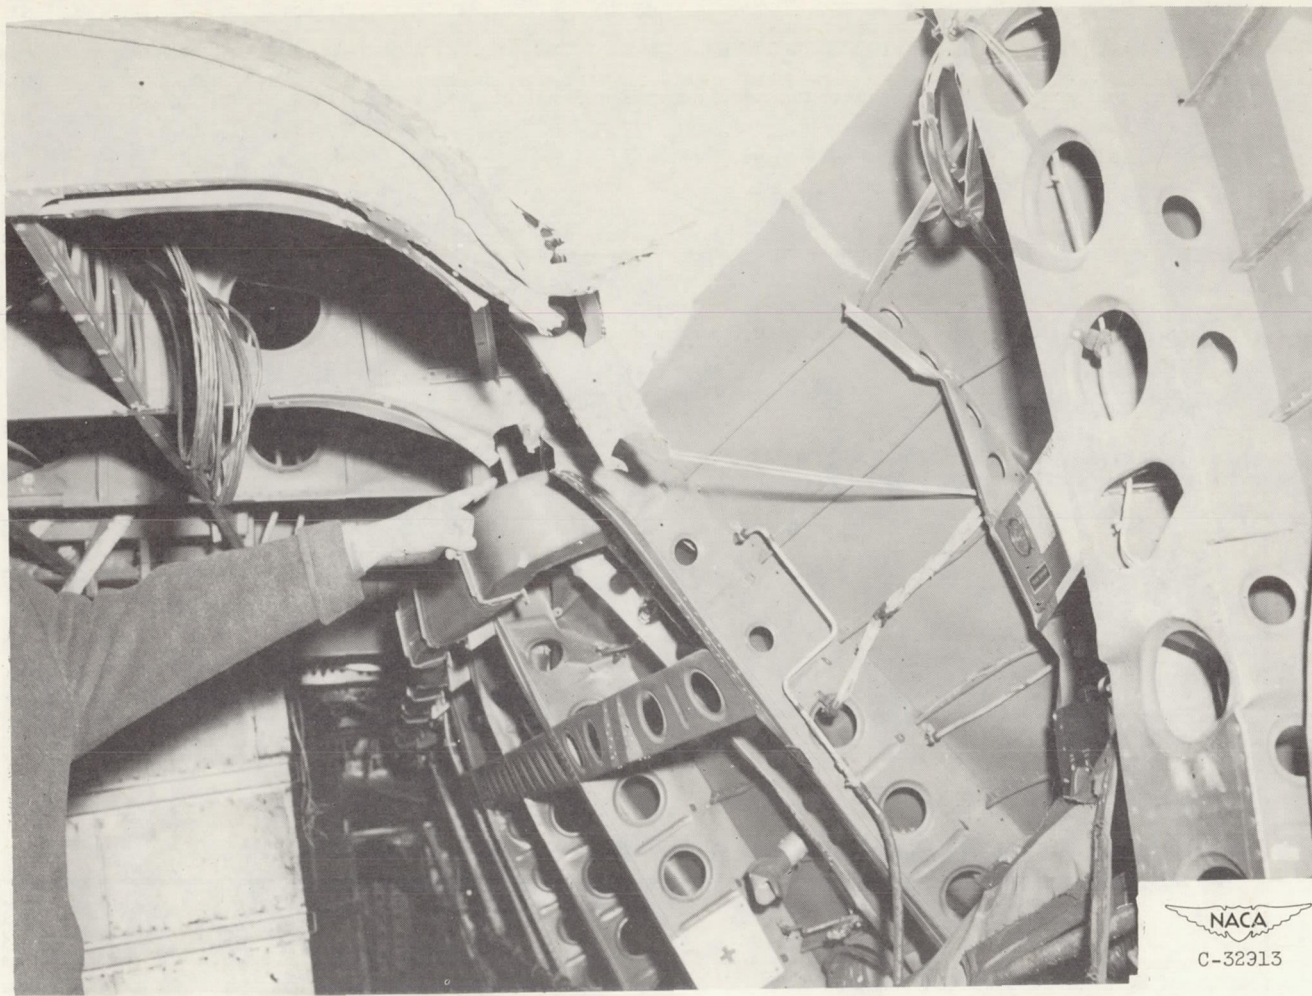
Figure 43. - Continued. Incipient lateral collapse of rectangular-type fuselage framing resulting from lateral load imposed by ground-loop crash.

(d) Fractured connection between side frame and ceiling members.
